# Leaving the Meter Running: A Survey of Furman University's Energy Consumption

Andrew Yowler and Marcus Jones, Introduction to GIS, Fall 2009

Department of Earth and Environmental Sciences, Furman University, Greenville, SC 29613

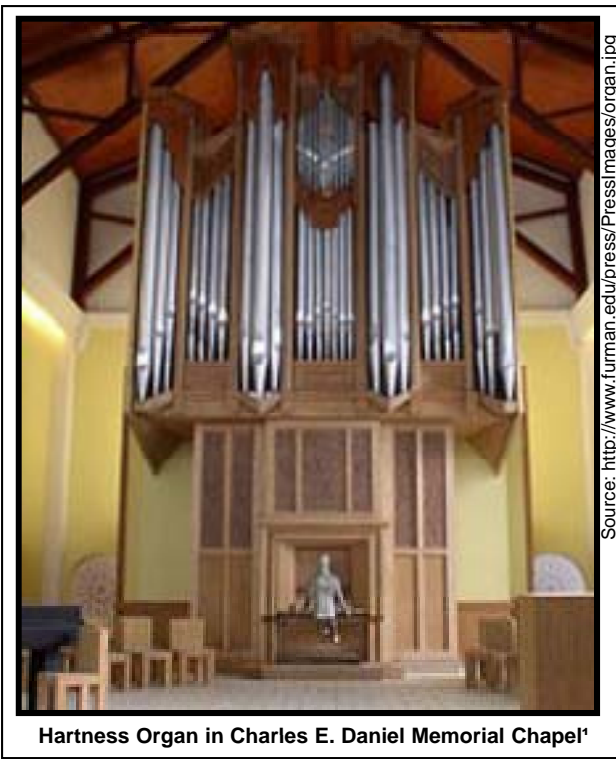
After analyzing the data, attention should be directed at high energy consumption in particular Furman University campus buildings. **Surprisingly, amongst all campus buildings, the Daniel Memorial Chapel consumes the most average monthly energy per square foot** (fig. 1,2,7). After further research, Facilities Services notes that high usage is largely due to two factors:

- 1) The building's lighting is costly with 250 dimmable outdoor lights to illuminate the exterior. Unfortunately, more energy efficient light bulbs (CFL bulbs) are not yet reliable enough to last multiple years outdoors, and LED light bulbs are not bright enough.
- 2) The chapel's pipe organ demands precise climate control to remain tuned. The sanctuary's HVAC operates 24 hours a day to maintain a constant temperature and humidity level.

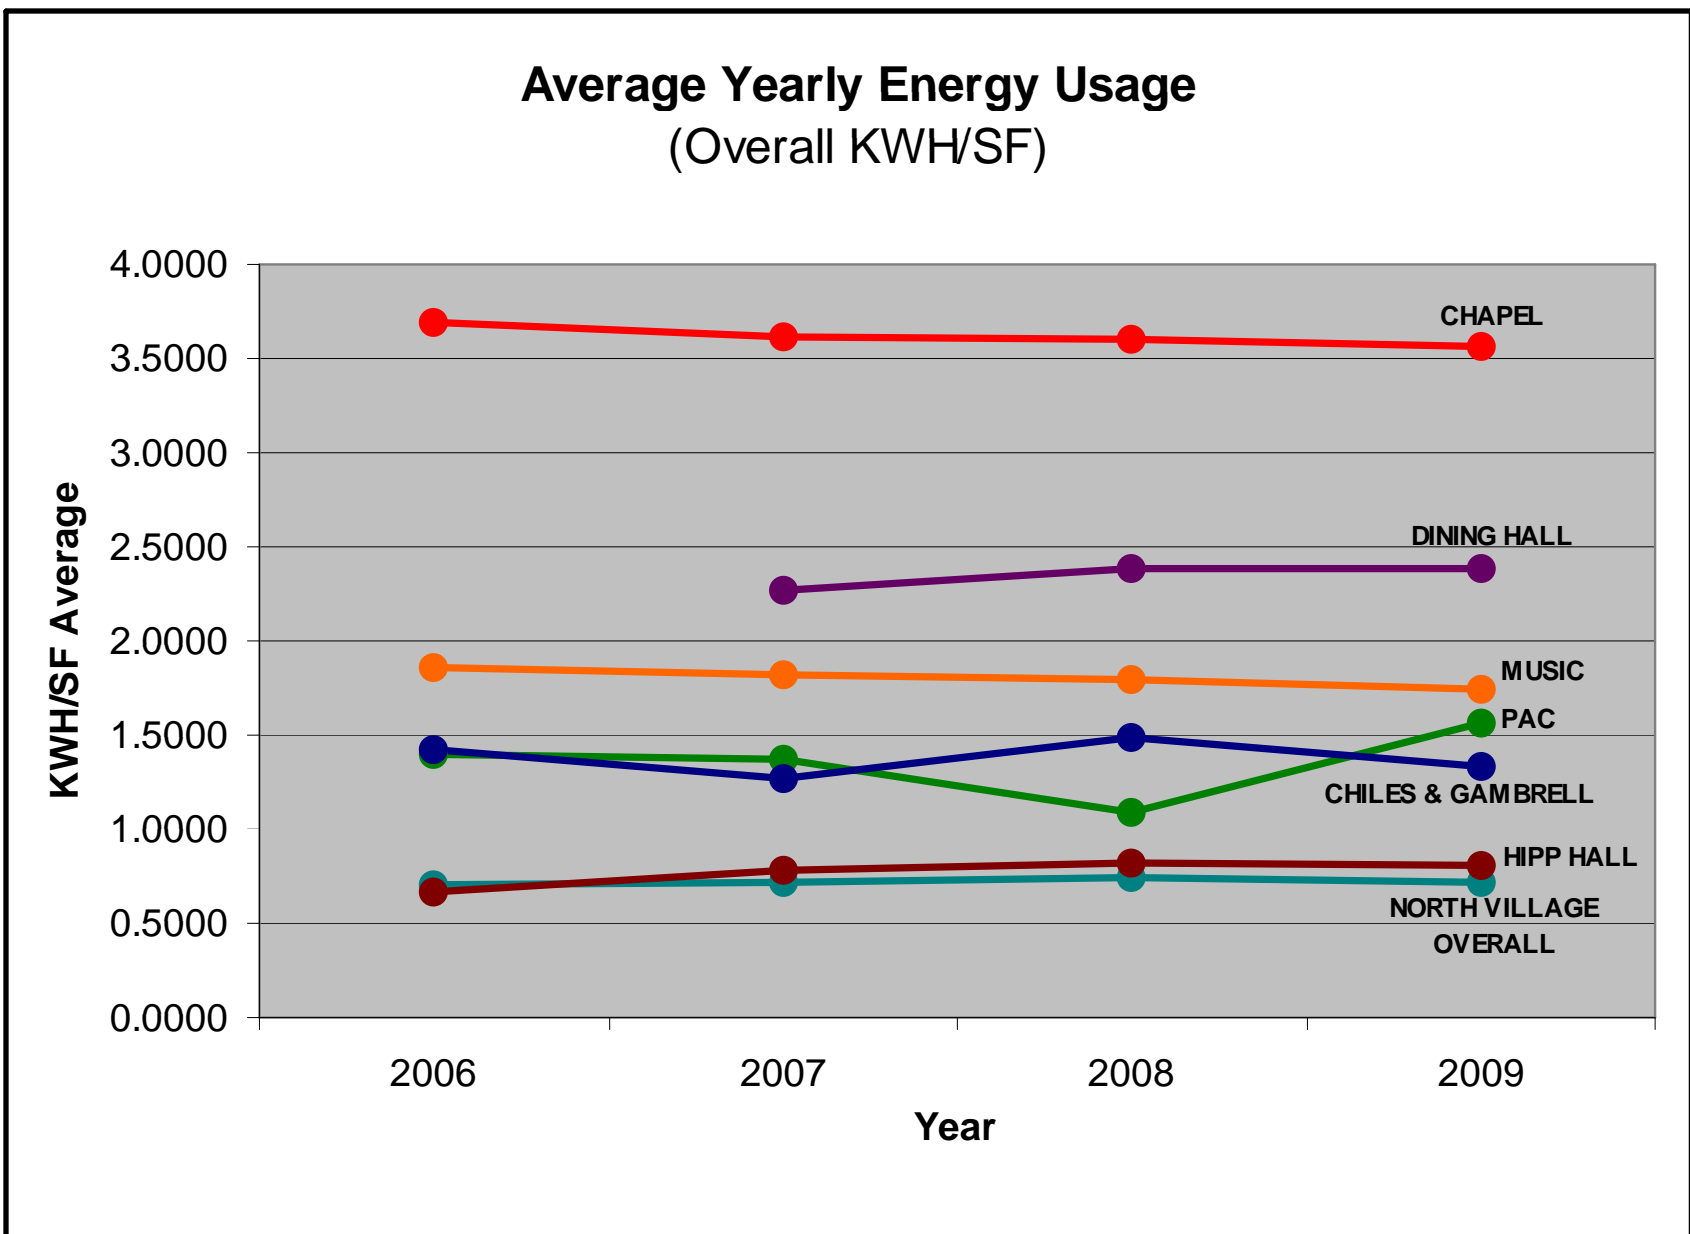
FIGURE 7: Chart comparing average usage between least efficient and more efficient buildings.
